# SAFETY ALERT 04/23 – RIGID INFLATABLE BOATS

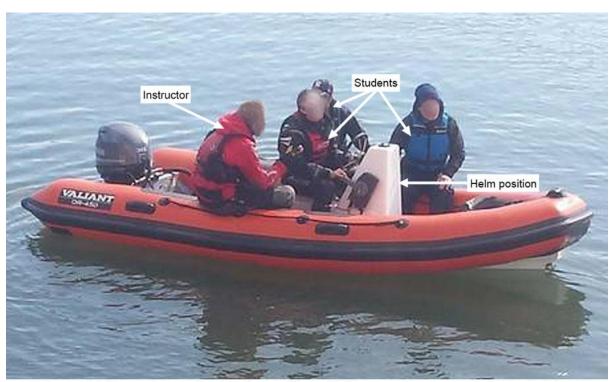
Three students were being taught by one of the sailing club's RYA powerboat instructors on board Midsummer, a rigid inflatable boat (RIB) owned by the club. The instructor had demonstrated an MOB recovery procedure using a buoyancy aid to simulate the casualty before starting the practical exercise. One of the students then took the helm, the two other students sat on the port side sponson and the instructor sat on the starboard side sponson (Figure 1).

Figure 1: Library picture showing the position of *Midsummer's* occupants during training (The students on the port sponson were sitting further aft on 29 June 2023)

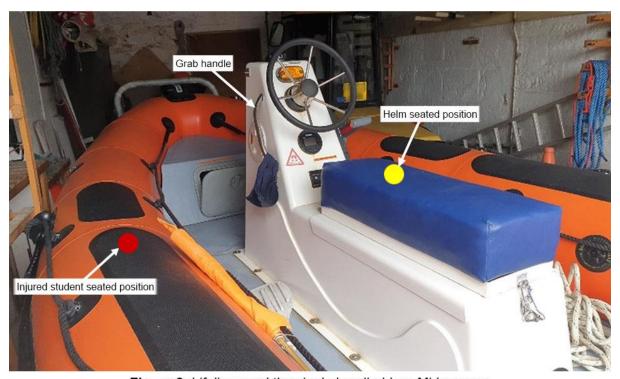
The boat used for the training was a Valiant 4.5m RIB fitted with a 30 horsepower outboard engine. It was equipped with lifelines along the sponsons, had a single handhold on the port side of the console with a two-person seat attached (Figure 2).

Figure 2: Lifelines and the single handhold on Midsummer

- As the RIB started to turn it tilted away from the students on the port side sponson and they leant back to maintain their balance and not topple into the RIB.
- The student who fell overboard overbalanced and fell out of the boat because they were unable to reach a suitable handhold with which to steady themselves.
- Examination of the RIB showed that there were insufficient handholds available for three people to sit safely on the sponsons when the craft was underway.

- Amended its risk assessments and standard operating procedures.
- Engaged with an RYA trainer to ensure that all instructors have received a full day of continuing professional development.
- Fitted additional grab handles to both of its training RIBs.

Whilst rowing clubs may not necessarily conduct MOB training, there will be clubs that use similar RIBs for coaching and/or safety purposes. The potential exists for a similar incident to occur if, for any reason, a RIB turns at speed and passengers are sitting on the boat's sponsons without accessible hand holds. Clubs operating similar RIBs should review their risk assessments and ensure that controls are in place to either ensure passengers do not sit on sponsons or that suitable and sufficient handholds are in place.
